# the Frontlines of Nuclear Energy

## Part 5 | FIELD REPORT

### To the Frontlines of the Decommissioning of Fukushima Daiichi Nuclear Power Station—Tracing the Path Forward through Reporting from the Field

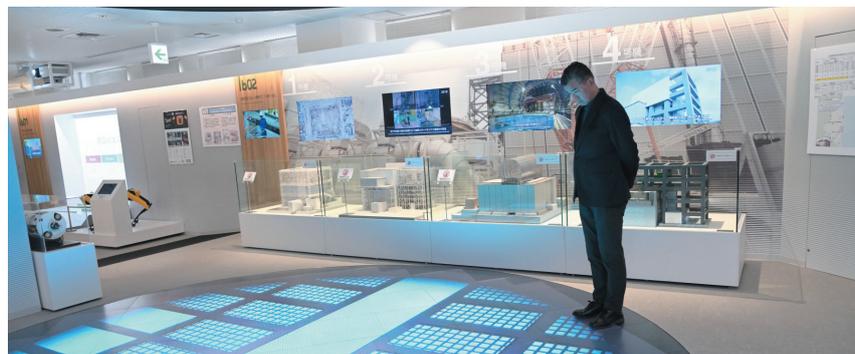
In a display showing activities to investigate the interior of the primary containment vessels, visitors can gain a feel for the actual size of the containment vessel through images projected on the floor.

Next, after going through panel displays explaining how radioactive waste is treated and stored, displays describe activities to investigate the interior of the primary containment vessels. The displays on investigations of the containment vessel interiors have models representing some of the robots used, including Hitachi's PMORPH shape-shifting robot that was used to investigate Unit 1. Visitors can also view

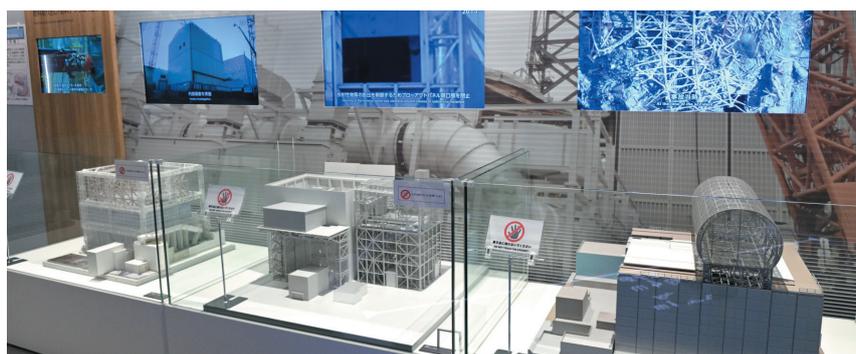
Models show the current state of the buildings housing Units 1 through 4.

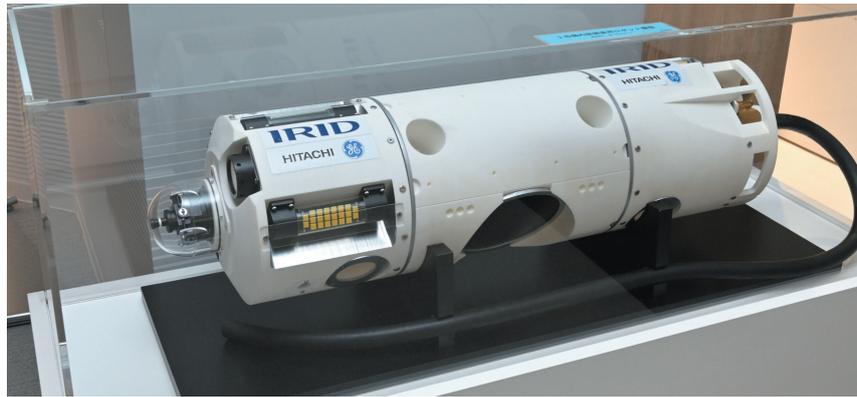
Model of a robot used to investigate the interior of Unit 1

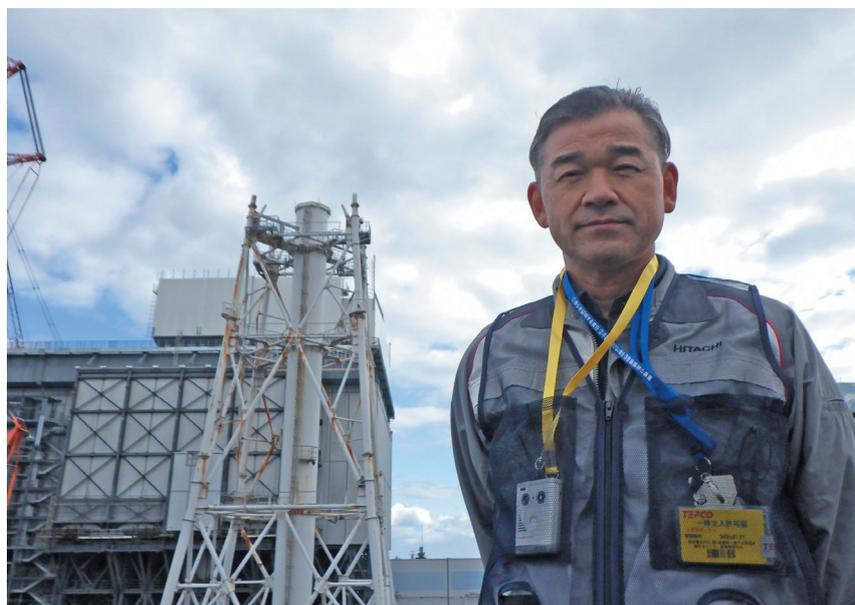
Visible on the left is the Unit 1 building and exhaust stack. During the tour, preparations were underway to install a large cover over Unit 1.

ago. At Unit 1, the installation of a large cover placed over the reactor building in preparation for the removal of fuel from the spent fuel pool is complete. Preparations are now being made to remove rubble from the operating floor. The removal of fuel from the pool is scheduled to commence sometime between fiscal 2027 and fiscal 2028. At Unit 2, preparations including the installation of fuel handling equipment are proceeding on the south side of the building ahead of the start of fuel removal scheduled for as early as the first quarter of fiscal 2026. The removal of fuel from inside the spent fuel pools of Units 3 and 4 is already complete.

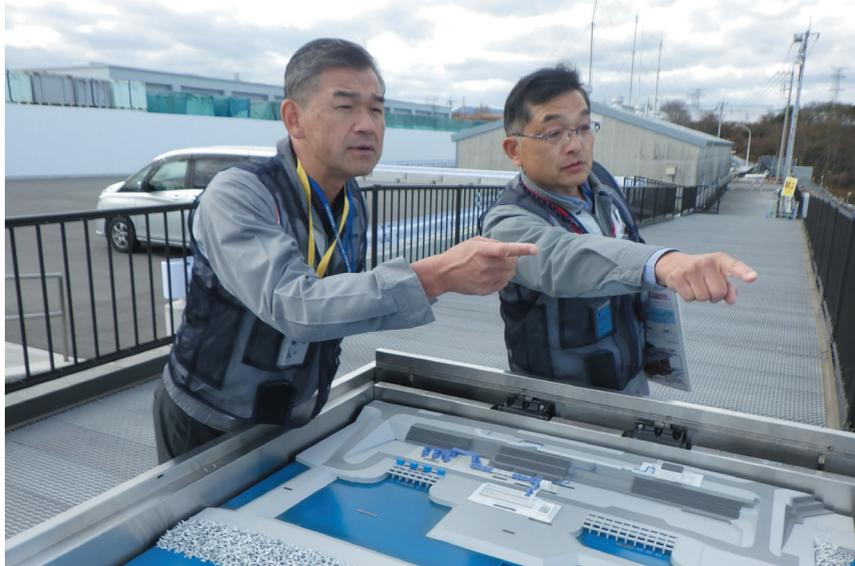
The Green Deck, which looks out over the ALPS treated water dilution and discharge facility, also features a scale model of the facility.

The facility, constructed on the shore near Units 5 and 6, plays the role of taking in seawater, mixing it with

treated water, and discharging the diluted treated water offshore. From the “Green Deck,” which was installed to provide a view of the treatment facility, you can look out across the Pacific Ocean and also see large tanks that buckled due to the tsunami and have been left in place along the shoreline. The location gives a renewed appreciation for the forces imparted by the massive tsunami.

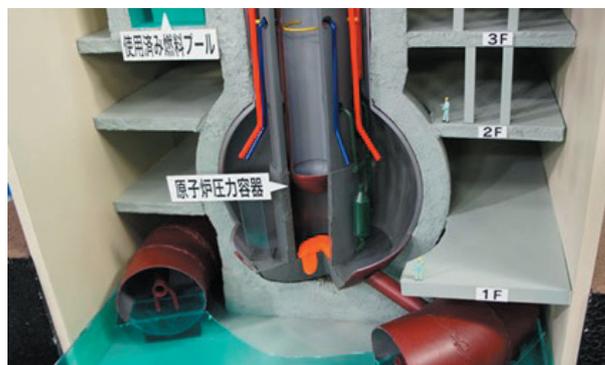
A 1/144th scale model of Unit 1 of the Fukushima Daiichi Nuclear Power Station that Matsui created himself at home in 2011 to explain the situation on news programs. The cutaway model of the pedestal section recreates the sight of how contaminated water accumulates and is designed to show how the melted-down fuel has eroded the bottom of the containment vessel.
