Work on Reconstruction of Electrical Systems at Sendai's Minami-Gamo Sewage Treatment Center Following Great East Japan Earthquake

OVERVIEW: Many of the sewage treatment facilities sited along the Pacific coast of Tohoku suffered serious damage from the Great East Japan Earthquake. This damage was considerably worse than expected and is taking a long time to recover from. Hitachi has been involved in work on electrical equipment for improving the water quality of treated sewage at the Minami-Gamo Sewage Treatment Center in Sendai City from the period immediately after the earthquake right up to the present day, the final fiscal year of the designated "concentrated reconstruction period" (FY2011 to FY2015). This article describes this involvement and what has been learned from the knowledge and experience gained through this work in terms of how best to enable electrical equipment to cope with disasters.

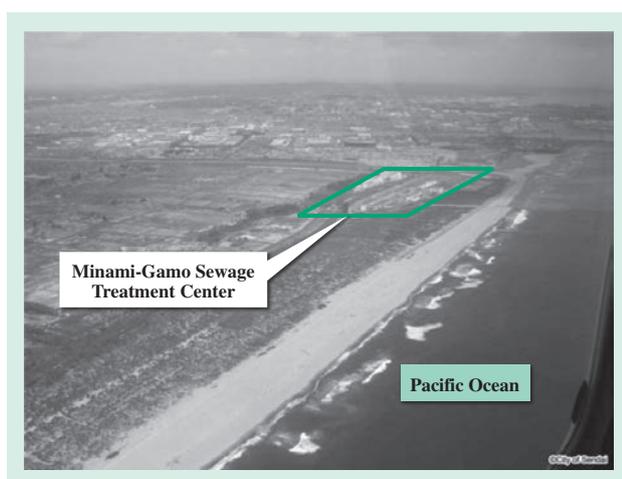
Fig. 1—Aerial View of Minami-Gamo Sewage Treatment Center. The Minami-Gamo Sewage Treatment Center, shown here after the earthquake, is located on the Pacific coast. Among the damage caused by the tsunami was the washing away of the coastal forest.

SENDAI City's Minami-Gamo Sewage Treatment Center located on the Pacific coast suffered devastating damage from the tsunami that followed the Great East Japan Earthquake that struck at 2:46 PM on March 11, 2011 (see Fig. 1)^{(1), (2)}.

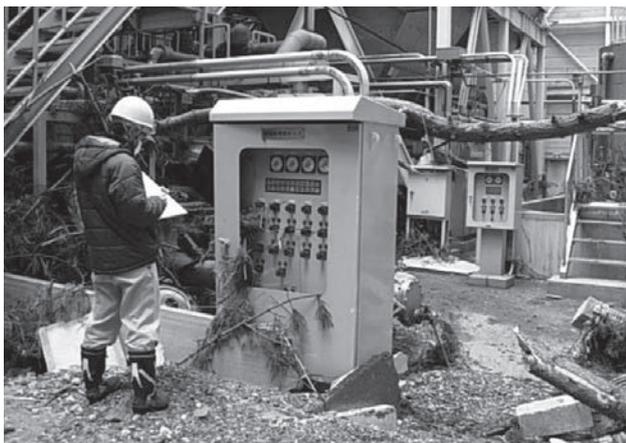
Fig. 2—Damage Survey in Progress.
Conducting the survey on a site still bearing the scars of the disaster was a difficult task.

Along with the difficulty of obtaining gasoline, food, and drinking water, the survey also faced difficult sanitary challenges with the site still bearing the scars of the recent disaster (see Fig. 2).

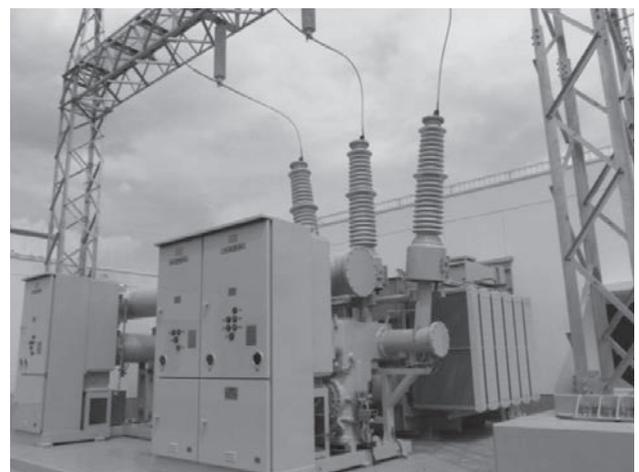
Fig. 4—Fully Restored Extra-high Voltage Substation Equipment (GIS).

By locating structural components on a raised embankment, the restored GISs are located about 10 m above the ground line.

The gas-insulated switches (GISs) that had been located on an outdoor, above-ground compound were deemed irreparable due to the ingress of seawater, so the gas was recovered from the tanks and the units were removed and disposed of on September 20. On the other hand, it was decided to take the transformers that had escaped damage due to water ingress back to the factory for refurbishment, and work commenced on their removal. In April of 2012, the replacement GISs were delivered to the site together with the refurbished transformers that had been cleaned, dismantled, had their radiators replaced, and repainted. After testing, adjustment, and a voluntary pre-operational inspection had been completed, supply of extra-high voltage electric power went live on June 12, more than a year after the earthquake (see Fig. 4).
